WATER QUALITY RESTORATION PLAN AND TOTAL MAXIMUM DAILY LOADS (TMDL) FOR THE BOBTAIL CREEK WATERSHED

January, 2005

Heidi Lindgren, Montana Department of Environmental Quality

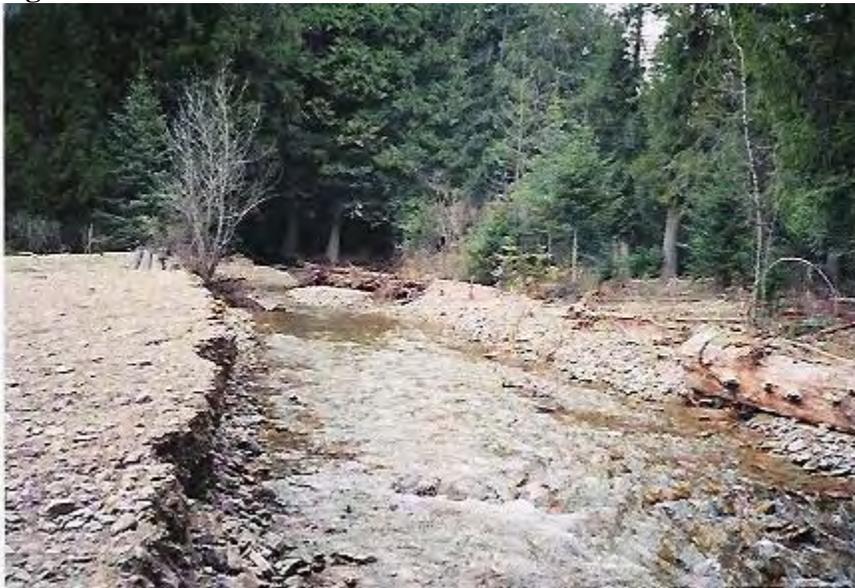
Figure 4-4. Area of Unstable Stream Reach.

Bobtail Creek's problems, in part, stem from extreme erosion caused when the stream jumped out of its banks and ran down a skid road that a small-private landowner built adjacent to the stream when logging their property in the late 1980's. The diversion of the stream down this skid road first occurred during severe rain-on-snow events in the fall of 1990 and spring of 1991. MDEQ analyzed this situation in a warning letter submitted to the private landowner. Additional events in February 1996, spring 1997, and more recent floods have continued to erode this unstable reach, leading to extensive channel aggradation downstream (Plum Creek Timber, 2004).

In October 1999, the Bobtail Creek Watershed Group conducted field reviews of private holdings in unstable reaches in sections 29, 30, and 32 (T32N R31W) (Figure 2-4). Steve Wegner, a professional hydrologist with the USFS conducted these evaluations in conjunction with private property owners. These evaluations identified areas of eroding bank and channel instability in these reaches that contribute to sediment loading and reduced transport leading to siltation. Of considerable concern is a section where the stream left its historical channel and scoured an overflow channel 15 feet wide and 3 feet deep (Figure 4-4). This continues to act as a potential source of sediment loading to the stream. Other sources of sediment loading and habitat degradation from private land holdings include livestock grazing, private roads, and stream encroachment.
