Stimson Cooling Pond PCB Cleanup Project

Update

May 2011

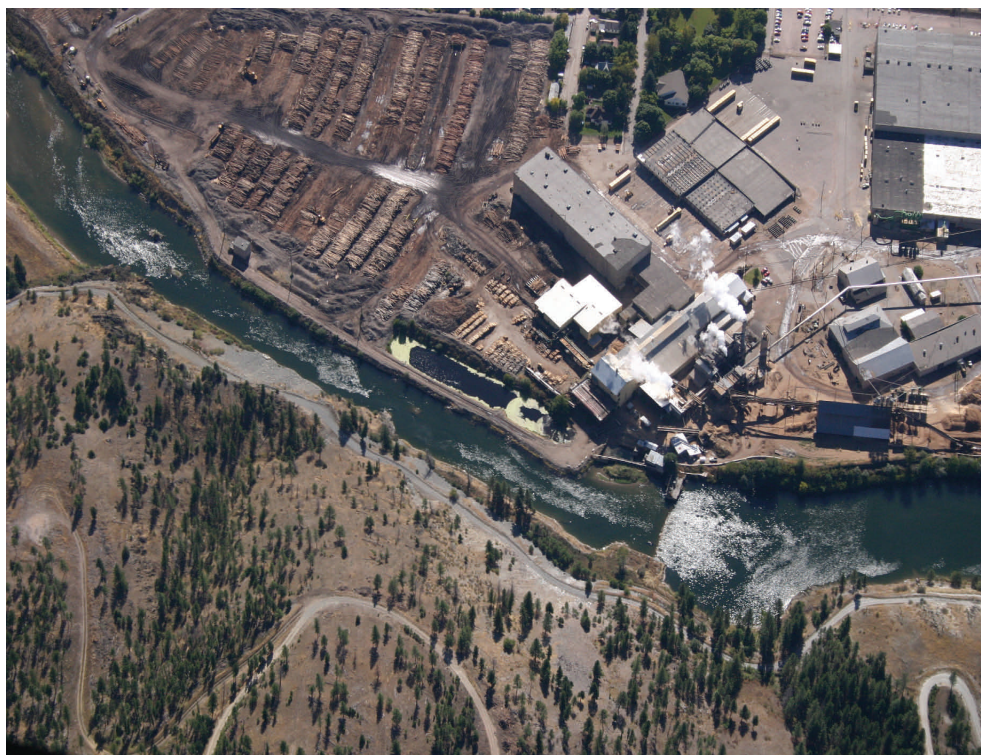
Photo courtesy of
U.S. Army Corps of Engineers

Two photos are included within this update, both photos are looking in a southern direction; north is at the bottom of the photo and the river flows from left to right. The first photo included, taken in the fall of 2005 just before the removal of the Bonner Dam, shows the cooling pond and fire pond lagoon areas, along with associated buildings and structure, and the northern end of the stud mill, all in-place and actively being used by Stimson.

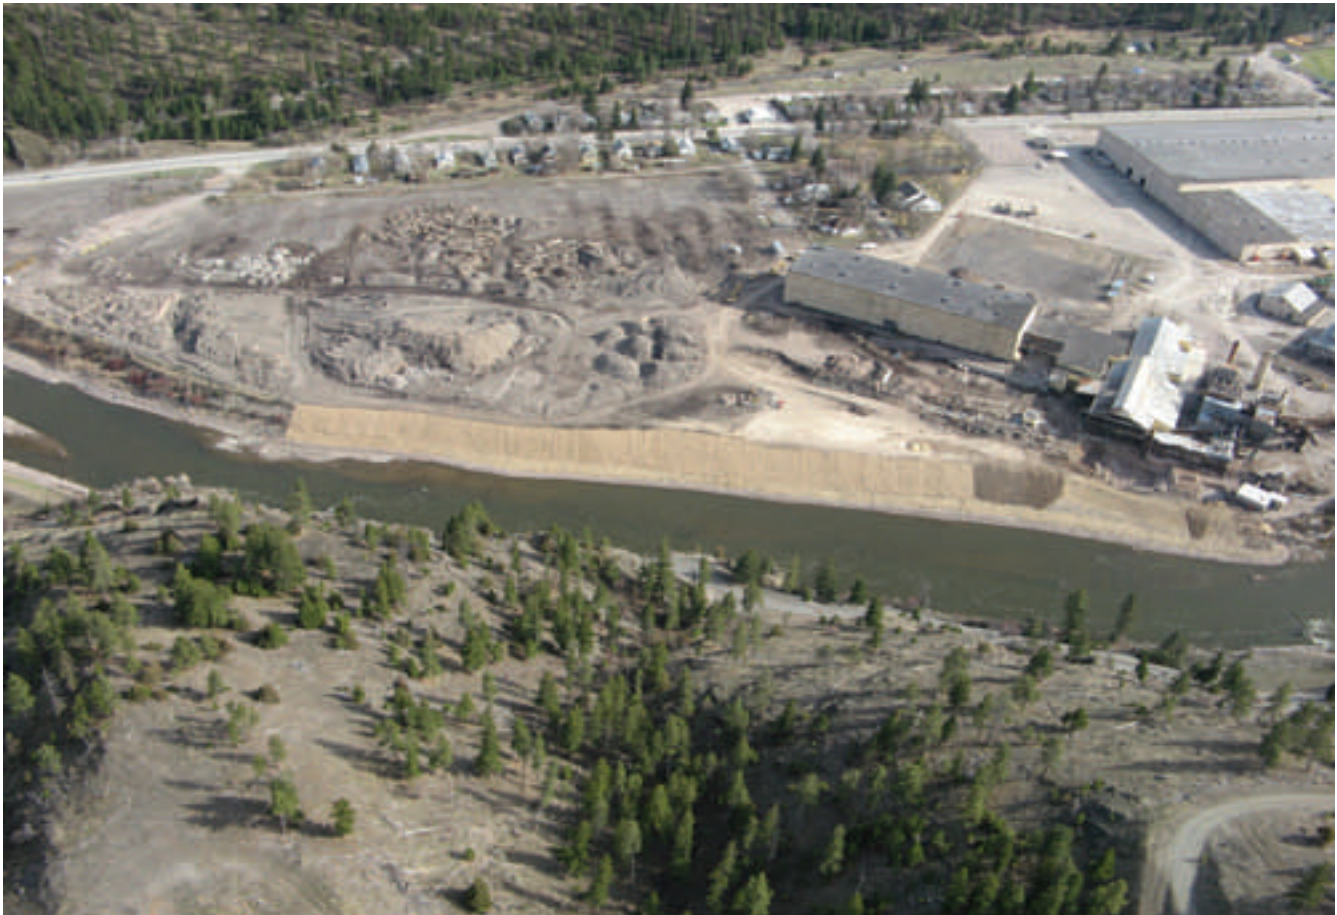
Photo courtesy of
Judy and Gary Matson

The second photo included, taken April 20, 2011, show that the former cooling pond and fire pond lagoon areas have been dramatically altered. The fire pond lagoon area located immediately upstream from the former Bonner dam, the cooling pond and sediments, the upland fire pond lagoon area and contaminated soils, the red iron deck located north of the stud mill, 100 feet of the northern end of the stud mill and the buildings near the ponds, have all been removed. In this photo, the newly reconstructed river bank is also seen as it was about one week before re-vegetation began.

However, Stimson is still addressing nearly 42,000 cubic yards of PCB contaminated materials now located in the former east log yard area and a large amount of timber cribbing and logs also located in the east log yard. The materials are located outside the 100 year floodplain so they are safe from any spring flood event.
